Shower Room

Architectural and Commercial

Application: Shower Drain Covers

Product: Aqua Grate® Pultruded Grating

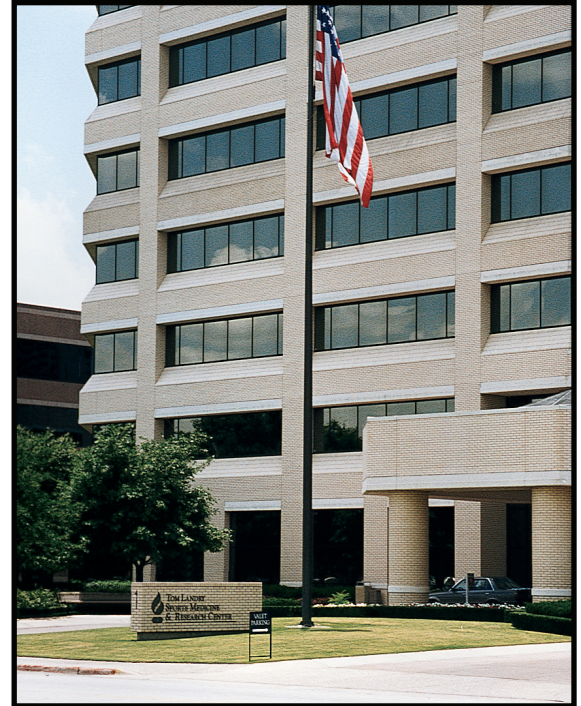
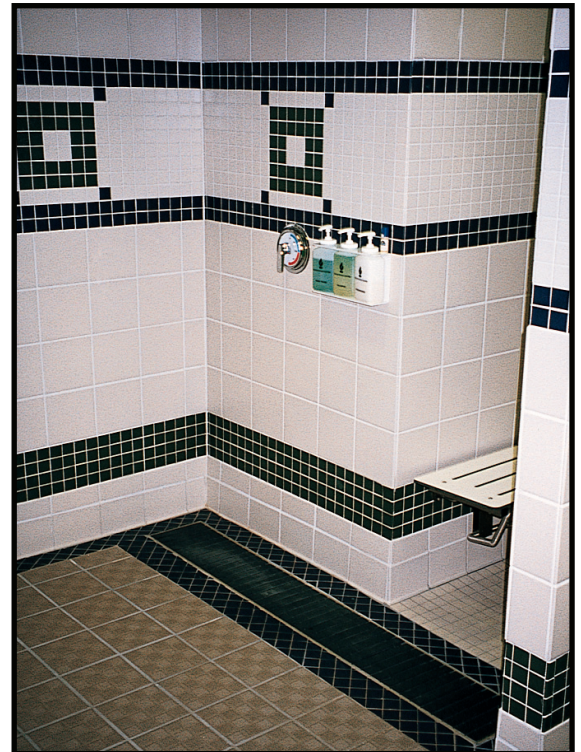
The facility chose Fibergrate's Aqua Grate® pultruded pedestrian grating to cover the drains in their training center locker rooms. The drains varied in length and were approximately 10" in width. Because the drains were narrow in width, 6" tie bar spacing was used for the 1" deep pultruded grating. The Aqua Grate® T1210 grating with its standard silica sand grit provides a safe, slip-resistant surface, yet is gentle on the players' feet.

The gray, built-in color also blends well with the shower walls and floor and will not require future painting by the maintenance crew. Because Fibergrate offers corrosion resistant products, they won't have to worry about scraping corroded grating either. Let Fibergrate Composite Structures solve your flooring or structural requirements.
