CASE STUDY Pharmaceutical

Location: Fort Worth, Texas **Application:** Walkways

Product: Fibergrate® Molded Grating

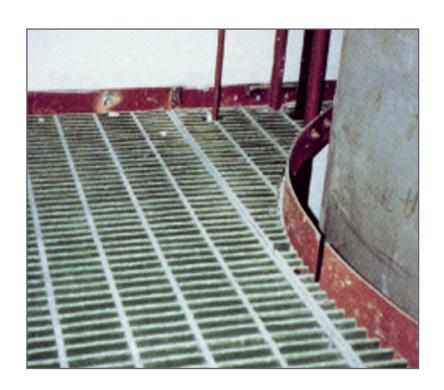
Alcon Labs selected Fibergrate® molded grating to fight the effects of corrosion and improve safety conditions. Flooring for rooms holding tanks of chemicals was the perfect place for Fibergrate to demonstrate its long life capability and slip-resistant properties. The pure blend of resin and continuous strand fiberglass results in a corrosion-resistant panel that provides years of use, without being deteriorated by the hostile chemical environment.

The slip-resistant surface of Fibergrate gives plant workers safe, sure surfaces on which to walk, despite slippery conditions resulting from grease, chemicals, oil or water. Fibergrate, when properly supported, has the structural characteristics of steel without its heavy weight. The outstanding corrosion resistance of molded grating offers a life span far beyond that of steel, even under harsh conditions.
